**Structural Stability Assessment of the Punit Park  
Cosmopolitan II CHSL, Plot No-182C, Sector 17, Nerul,  
Navi Mumbai**

**STRUCTURAL AUDIT REPORT**

**YASH ENGINEERING CONSULTANTS PVT LTD.**

**AUGUST 2022**

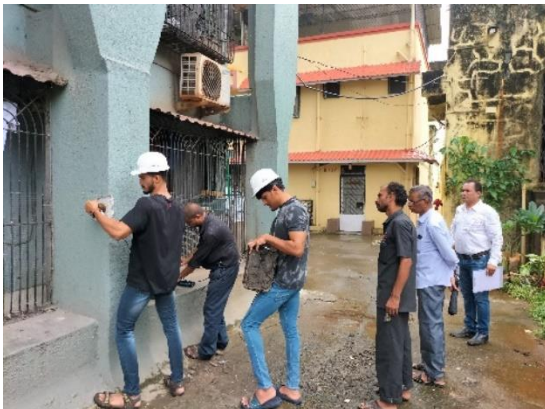
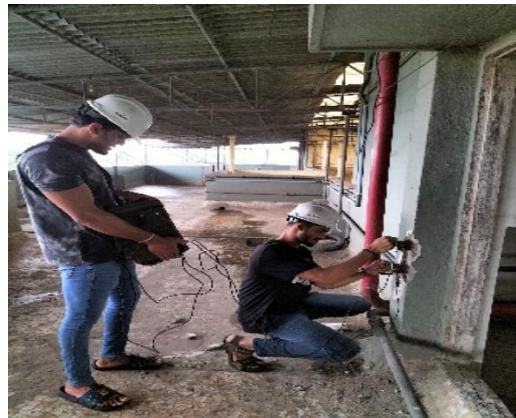
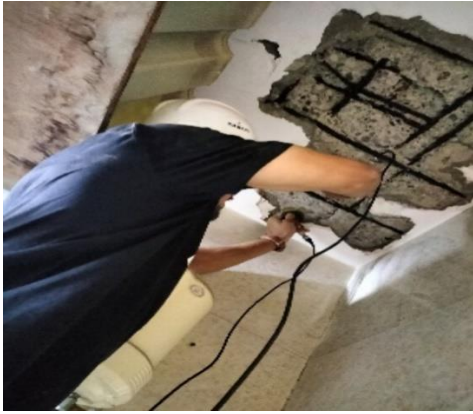
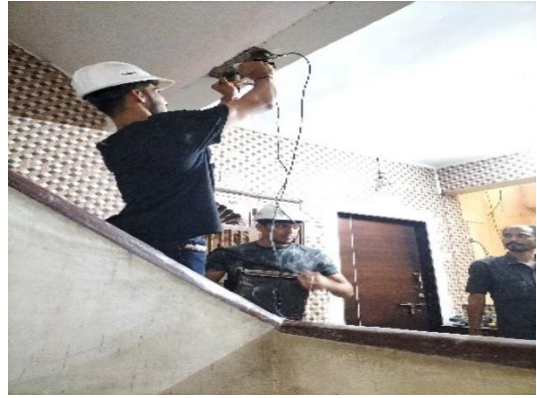
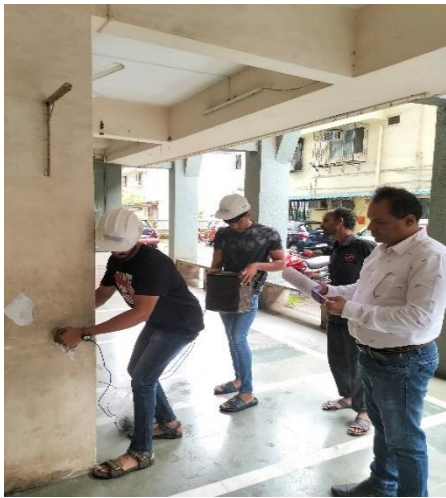
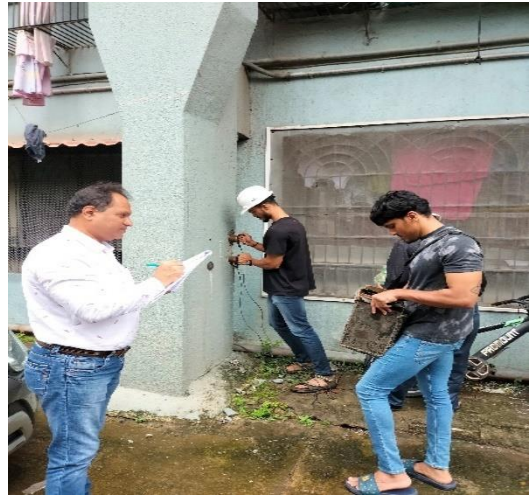
### Rebound Hammer Test

- 2) Rebound Hammer Test reading were taken on Columns, Beam etc. to assess the compressive Strength of these RCC members. Both horizontal and vertical up directions of testing were used. Accuracy of prediction of concrete strength by this method is + / - 25 % vide IS 13311 (part – 2) 1992. The Rebound reading observations on relevant members are also included in the report enclosed.

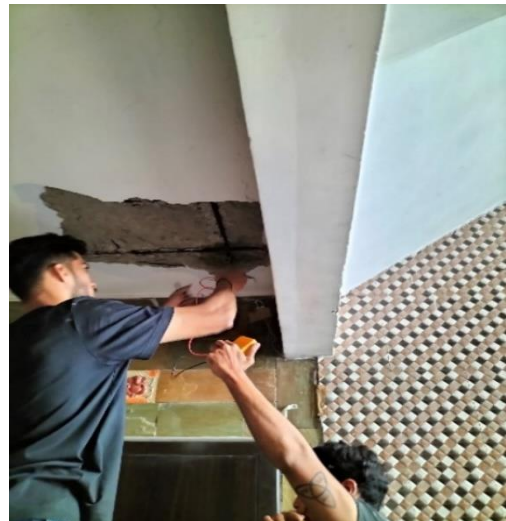
**Ultrasonic Pulse Velocity Test (UPV)**

- 1) The aim of testing was to arrive at the general quality of concrete, rather than evaluating each RCC members in details. Hence, a few RCC members at random were tested & Ultra Sonic Pulse Velocity (USPV) measurement were taken on RCC members i.e., Column, Beam & Slab. The pulse velocity observations on relevant members are included in the report.

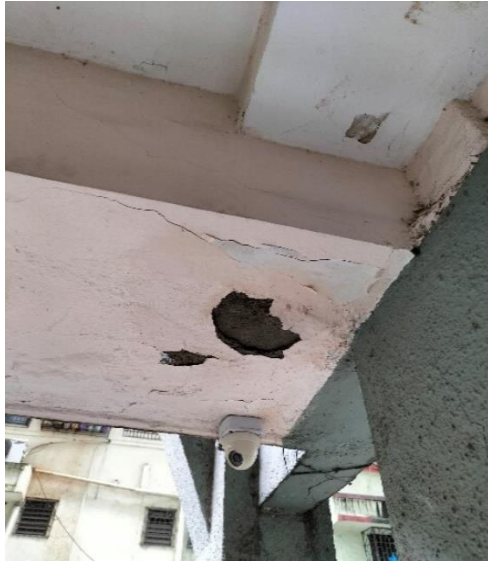
**Half Cell Potentiometer Test (Corrosion Test)**

- 3) Half Cell Test of embedded reinforcement was taken to identify the corrosion in reinforcement steel. The HCT reading observations are included in the report enclosed.

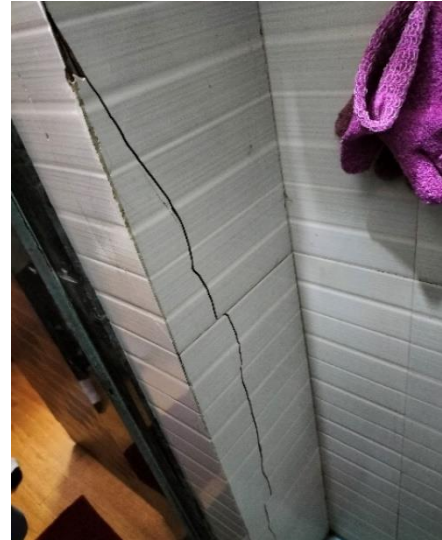
**Collapse of Slab**

1. The A, B, C & D Wing is structurally distressed and dilapidated and not recommended for habitation.
2. Rebound Hammer Test results of the Columns and beams of the A and B wings indicate the average concrete strength of the structure is not adequate (10-20 MPA).
3. Average UPV results of A & B wing indicate that most of the concrete has average structural integrity.
4. Average Carbonation test results shows more than 50% corrosion in reinforcement.

Based on the carbonation test results more than 50% corrosion in reinforcement it's an alarming situation. The Concrete strength is also on lower side as compared to current standards. The repairs to structure may not guarantee the future strength and life of structure. It will be prudent to Demolish these buildings.

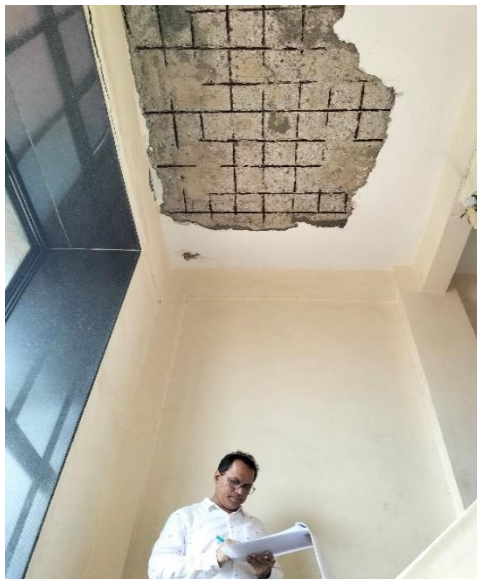
7. The staircase is minor distressed at various locations.
8. Ground floor to 7<sup>th</sup> floor column, beam & slab is showing major & minor cracks.
9. Columns are the most critical components in a structural system. The hammer is giving low values due to local dampness of surfaces. Considering all the factors it is suggested to provide encasing of concrete to the severely affected columns for immediate relief.

**Cracks in Column**

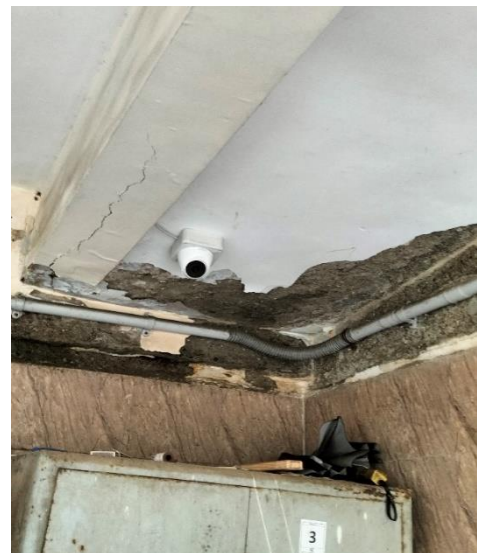
**Collapse of Slab**

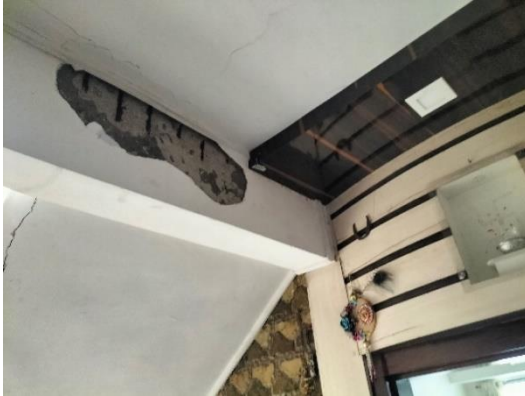
**Cracks in Beam and Slab**

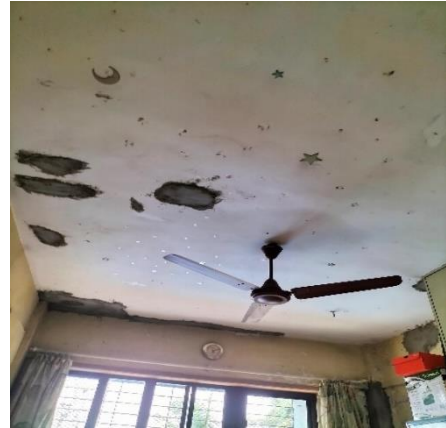
**Cracks in Beam and Slab**

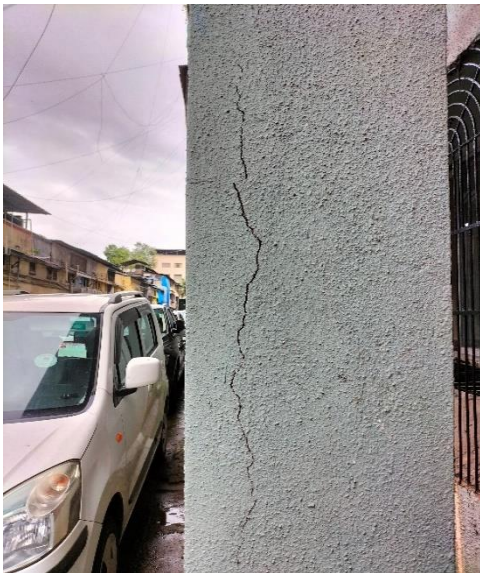
**Cracks in Beam and Slab**

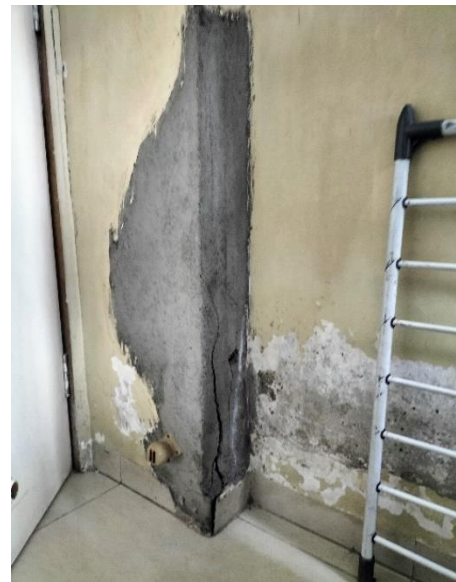
**Cracks in repaired Column**

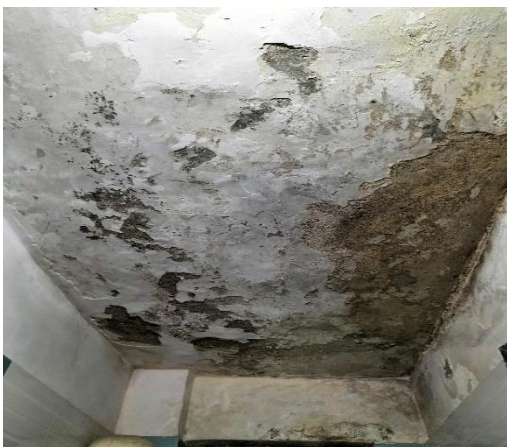
**(Critical)**
10. Vibration on floor of several flats & passages is observed during walking.
11. Leakages & Seepages marks were observed on RCC slab internally. Immediate attention is necessary to avoid the further deterioration.

**Leakages in Slab**

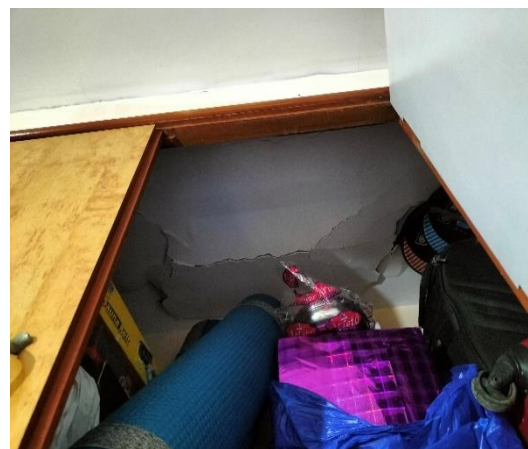
**Cracks in Slab**

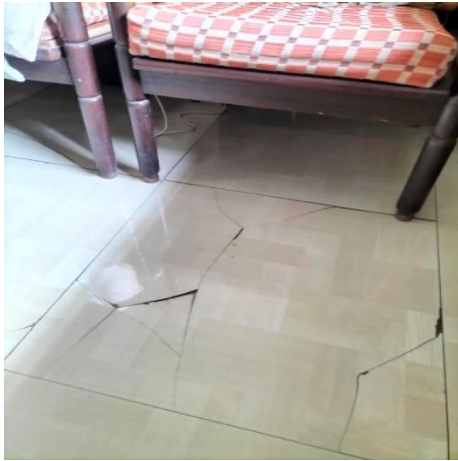
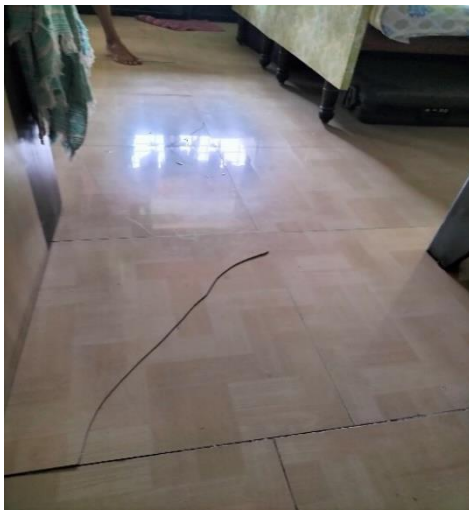
2. Major Crack are observed on column & beam in several area internally & externally.
3. Major undulation observed of flooring.
4. Overall, 80% tiles of flooring are damaged and shows undulation. Also, can be visually seen at flat no. A102, A002, A402, A404, 'B' wing 1st floor, 'C' wing 4th & 5th floor, 'D' wing 1st, 3rd & 4th floor including passages.

**Cracks in Flooring**
